MARYLAND HISTORICAL TRUST DETERMINATION OF ELIGIBILITY FORM

Property Name:	Hayman Farm (Historic Name	- Seward Farm)	Inventory Number:	CAR-362 CAR-35
Address: 23865 R	acetrack Road	City: Ridgely	Zip Code:	21660
County: Caro	bline	USGS Topographic Map	e: Ridgely, MD	
Owner: Caroline (County Commissioners	I	s the property being evaluate	ed a district? no
Tax Parcel Number	29 Tax Map Number:	17 Tax Account ID	Number: <u>07-003714</u>	
roject: Carolin	e County Airport	Age	ency: CCR, Inc.	
ite visit by MHT S	taff: X no yes	Name:	Date:	
the property locat	ed within a historic district?			
f the property is w	ithin a district		nventory Number:	
NR-listed district	yes Eligible district	yes District Na	ame:	**************************************
Preparer's Recomm			n-contributing but eligible in	
f the property is no	ot within a district (or the prope	erty is a district)		
Preparer's Recomm	nendation: Eligible	yes X no		
riteria:	A B C D C	onsiderations: A	B C D E	F G None

Property Name: Dreamland		Inventory Number:	CAR-356
Address: 23865 Race Track Road	City: Ridgely	Zip Code:	21660
County: Caroline	USGS Topographic Ma	p: Ridgely and Denton	
Owner: County Commissioners of Caroline Cou	mt

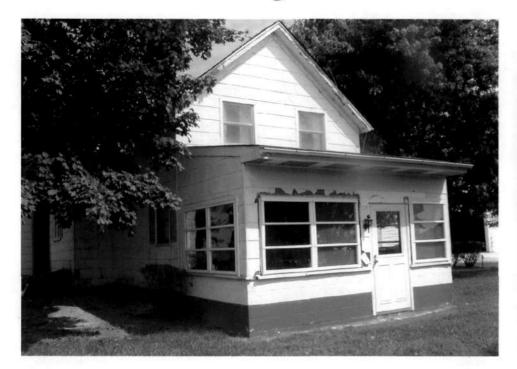
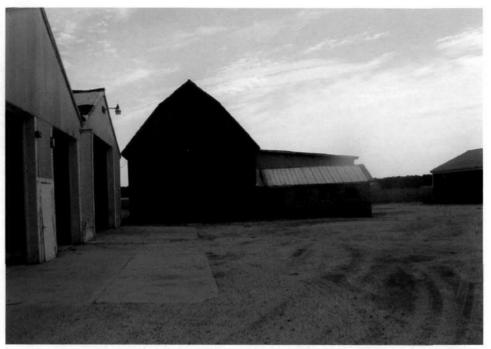
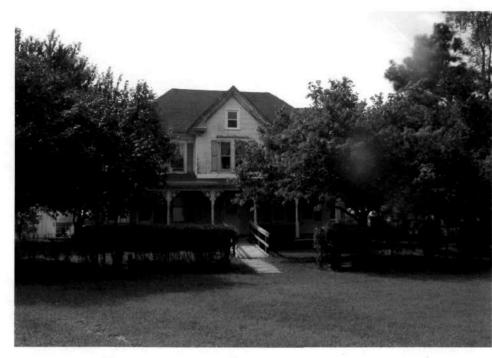
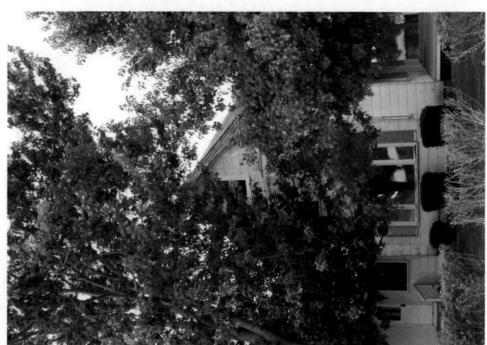
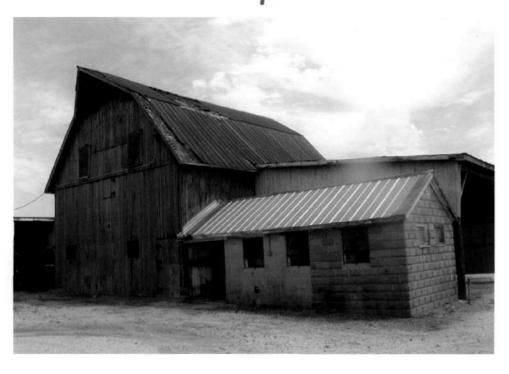
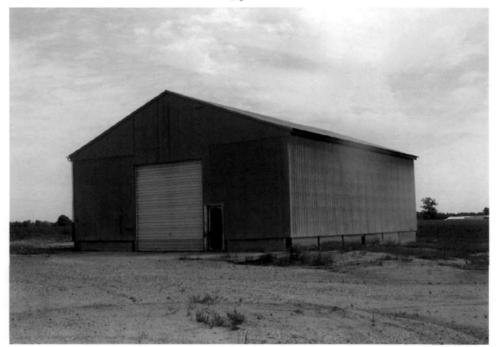
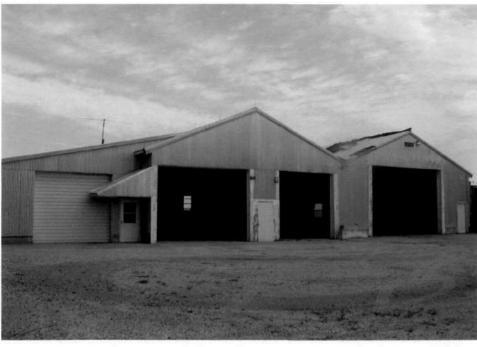
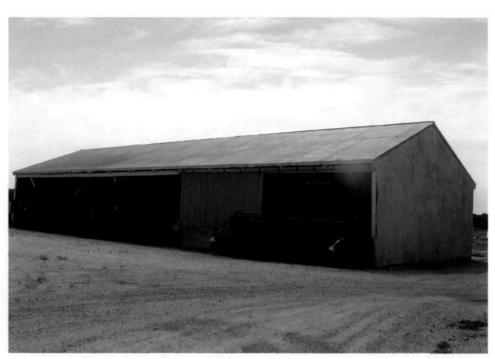
Image 356	Subject	MIHP#
CAR-362a	Hayman Farm, North Elevation (Front)	CAR-362-CAR-356
CAR- 362 b	Hayman Farm, Rear Elevation	CAR-362 CAR-356
CAR-362c	Hayman Farm, Side Elevation	CAR-362 CAR-356
CAR-362d	Hayman Farm, Barn	CAR-362-CAR-356
CAR-362e	Hayman Farm, Equipment Shed D	CAR-362 CAR-250
CAR-362f	Hayman Farm, Barn	
CAR-362g	Hayman Farm, Equipment Shed B	CAR-362 CAR-351
CAR-362h	Hayman Farm, Equipment Shed C	CAR-362 CAR-356 CAR-362 CAR-356 CAR-362 CAR-356
		377 350
*

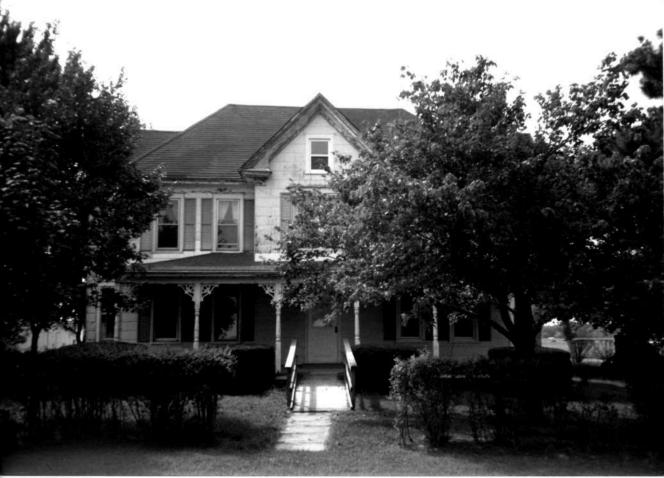
CAR-356 HAYMAN SEWARD FARM

VIEW OF HOUSE, NORTH ELEVATION

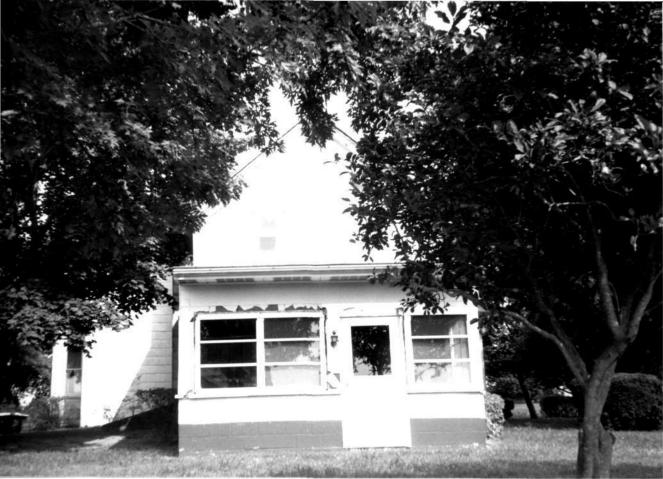
CAR-356 HAYMAN/SEWARD FARM

CARDLINE CO, MD 8/23/05 VIEW OF HOUSE, SOUTH ELEVATION ROLL 2/EXP9 JEN STEWART/COASTAL CAROLINA RESEARCH MD SHAD

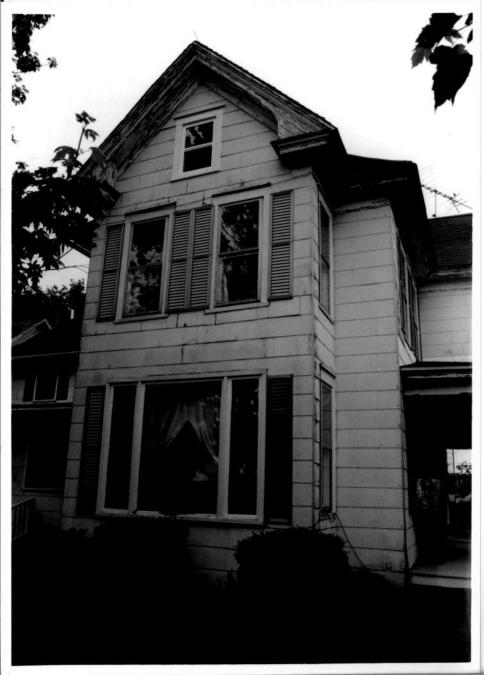
2 DF 11

CAR STO DREAM LAND CARDUNE COUNTY, HARYLAND CHEIDENPICH MUSIUS 2003 TAD SHIPA DUEWING, EAST ELENATION

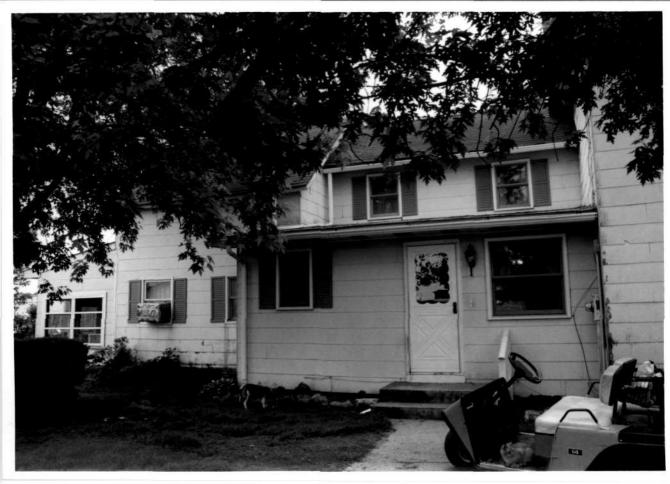
3 OF 11

HOTTERIAL SHE ELEVATION

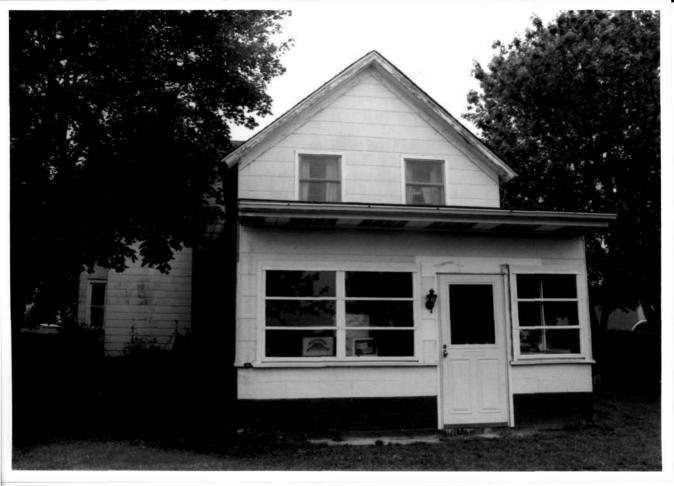
Three additions were constructed to the rear of the house. A one-and-a-half-story appendage on the south elevation, which was a former tenant house, has a shed roof and provides access to the kitchen. A one-and-a-half-story addition, which according to the current property owner also was a tenant house, was relocated behind the kitchen wing, on the south elevation of the dwelling. The addition has a square footprint and a gable roof. A one-story concrete block and asbestos-clad addition with a shed roof was appended south of the tenant house addition.

CAR 350
DREAMLAND
CAROLINE COUNTY, HAPYLAND
O. HEIDEMPICH
ALGUST 2003
HD SHAPO
DWELLING, SOUTH ELEVATION
40F 1

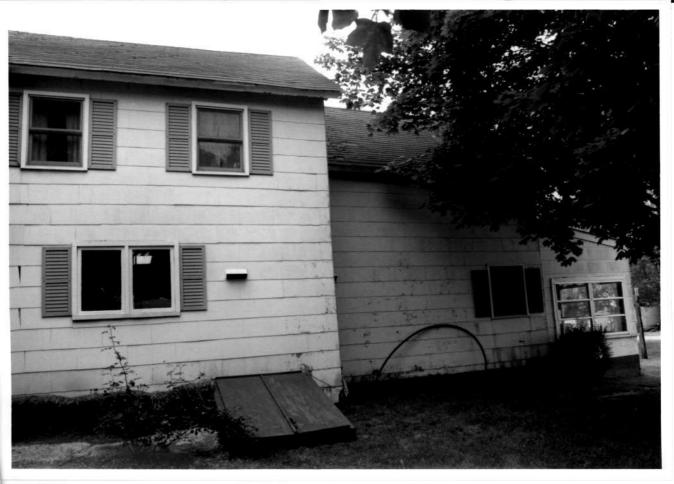
DUELLING, WENT ELENATION

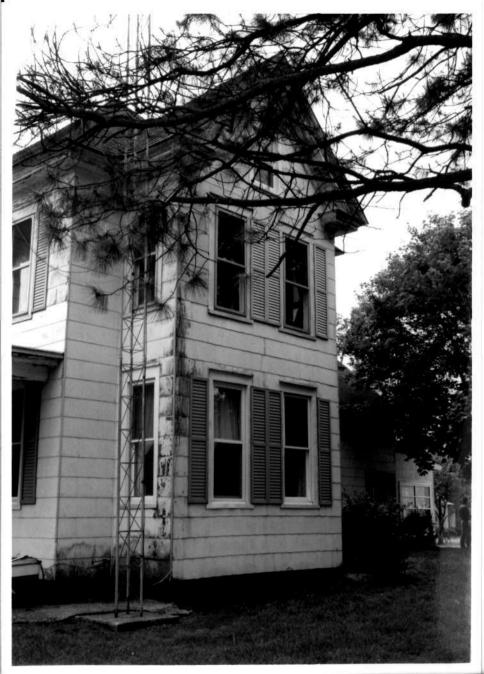
6 OF 11

DREMING, WEST ELEMATION

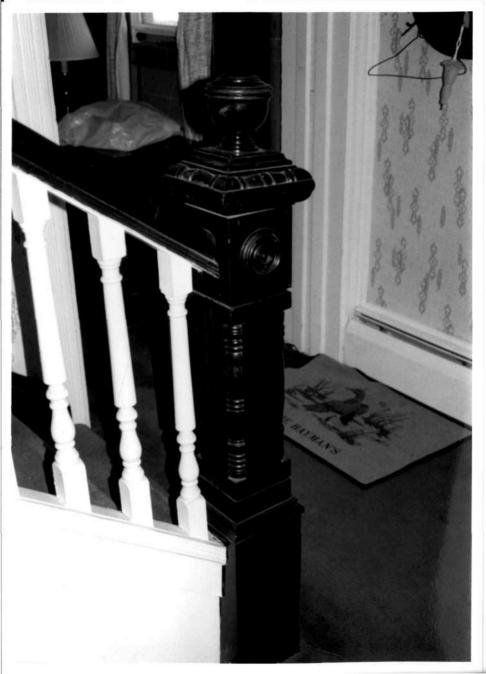
7 2511

The interior has a central hall with two parlors located on either side of the hall. The parlors extend the length of the original dwelling. Pocket doors separate the parlors from the hall. Direct access to the kitchen is from the east parlor. Windows and doors exhibit decorative wood molding with bull's eye corner blocks. An open stair from the hall leads to the second floor. The stair employs turned balusters and has a decorative square newel post, with a bull's eye corner block, quarter round turned spindles and a newel cap. The current tenants added the crown molding found in the east parlor when the ceiling was lowered. A wood mantel with two round columns, located in the southeast corner of the east parlor, was present when the Haymans acquired the property in 1961. The mantel is not attached to a chimney. The east parlor leads directly into the kitchen. A bathroom is located in the southeast corner of the kitchen. A pantry and dining area are located beyond the kitchen. The concrete block addition beyond houses a hot tub. The second floor has three bedrooms and a bathroom. The dwelling's interior has undergone significant alterations. The current tenants replaced the plaster walls with drywall and the ceiling in the east parlor was lowered by six inches. The kitchen ell also was

CAR 3560
DREAM LAND
CARDUNE COUNTY HARYLAND
CHEIDENRICH
AUGUST UNOS
NO SHOO
DUKLING, INTERIOR, HEUEL IDET

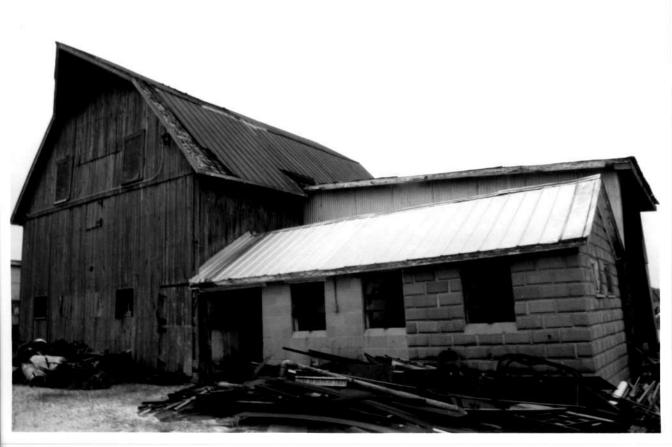
A small hay barn, constructed circa 1930, is located east of the residence. The barn is part of a complex of metal agricultural outbuildings constructed in the mid- and late twentieth century. Access to the barn is from a gravel drive that leads to a gravel parking lot. The wood-frame building occupies a rectangular footprint. The barn faces west. The building is one story with a loft. The building terminates in a steeply pitched, hipped gable roof, with a hay hood on the west elevation. The roof is sheathed in standing seam metal. Original roofing materials, which are visible under holes in the metal roof, consisted of cedar shakes. The exterior of the building is clad in vertical wood bead board. Windows are six-light, fixed-sash. Doors are found on the north, west, and south elevations. A loafing shed is attached to the rear (east) of the barn. The loafing shed is clad in vertical wood siding. The shed terminates in a low-pitched shed roof clad in standing seam metal. A single-story, concrete-block addition was constructed on the west elevation, to the south of the principal block. Six-light hopper windows and three-light, wood, fixed-sash windows characterize the addition. The addition terminates in a gable roof clad in standing seam metal. The area between the concrete block addition and the loafing shed, on the barn's south elevation, is partially enclosed by corrugated metal siding and a corrugated metal roof.

CAR:356 DREAM LAND CARDLINE COUNTY, MARYLAND ALGUST 2003, C. HELDEMRICH LID CHED HAY BARY & CONCRETE BLULL MODE 8 OF 11	man, utst Elevann
---	-------------------

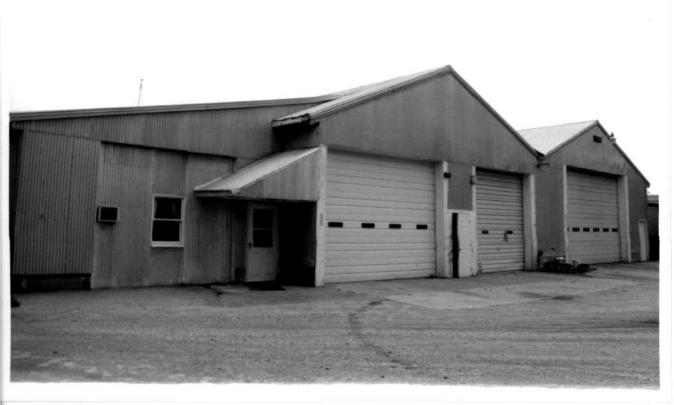
GARAGE, SWITT ELEGATION

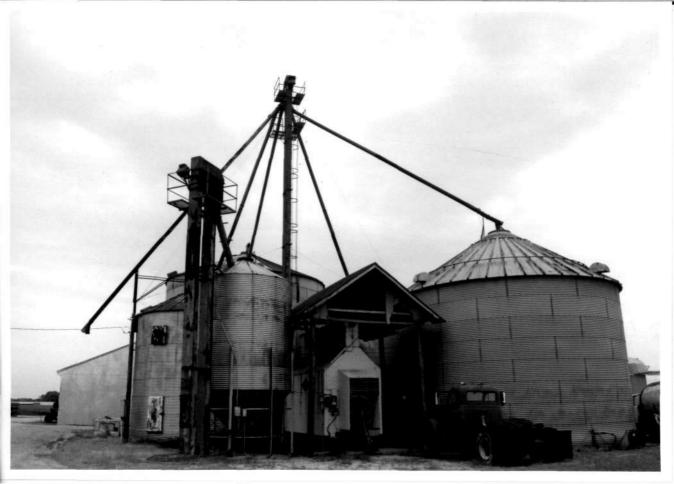
11 OF 11

According to the current tenant, the remaining agricultural buildings were constructed between 1966 and 1982 (Norris Hayman, personal communication, 29 May 2003 and 12 August 2003). Six buildings, including equipment sheds and two garages, and a complex containing three silos are located east and south of the dwelling. The buildings occupy rectangular or square footprints and have either poured concrete or dirt foundations. The buildings are clad in corrugated metal and terminate in shallow-pitched gable roofs sheathed in corrugated metal. The buildings lack exterior ornamentation, with openings consisting of garage doors and infrequent metal sash windows. The silos also are clad in corrugated metal and terminate in conical roofs clad in standing seam metal.

CARBON
BREALICAND
CARBONNE COUNTY, HAPPLAND
ANGUST, 2005, C. HEIDENFIRM
MD SHOO
SILOS, WEST ELEMATION
